### Progress Photo Examples:

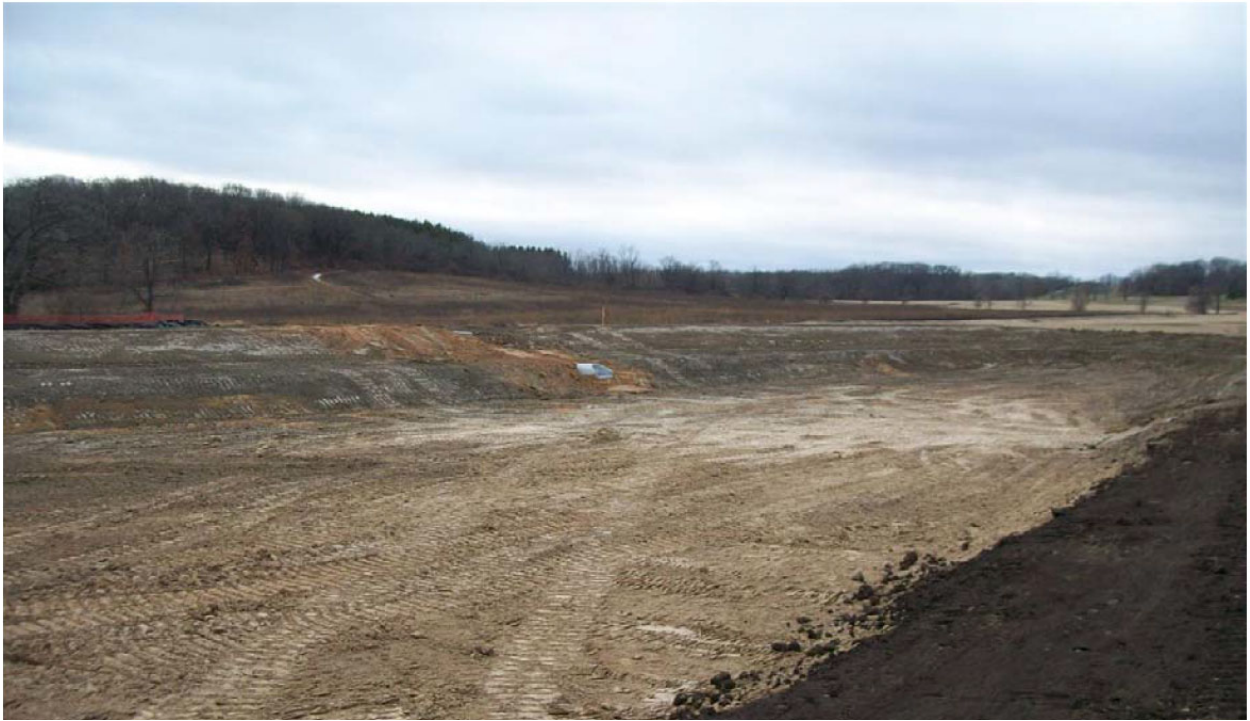
Photo 1: Wet basin looking south west at its initial grading

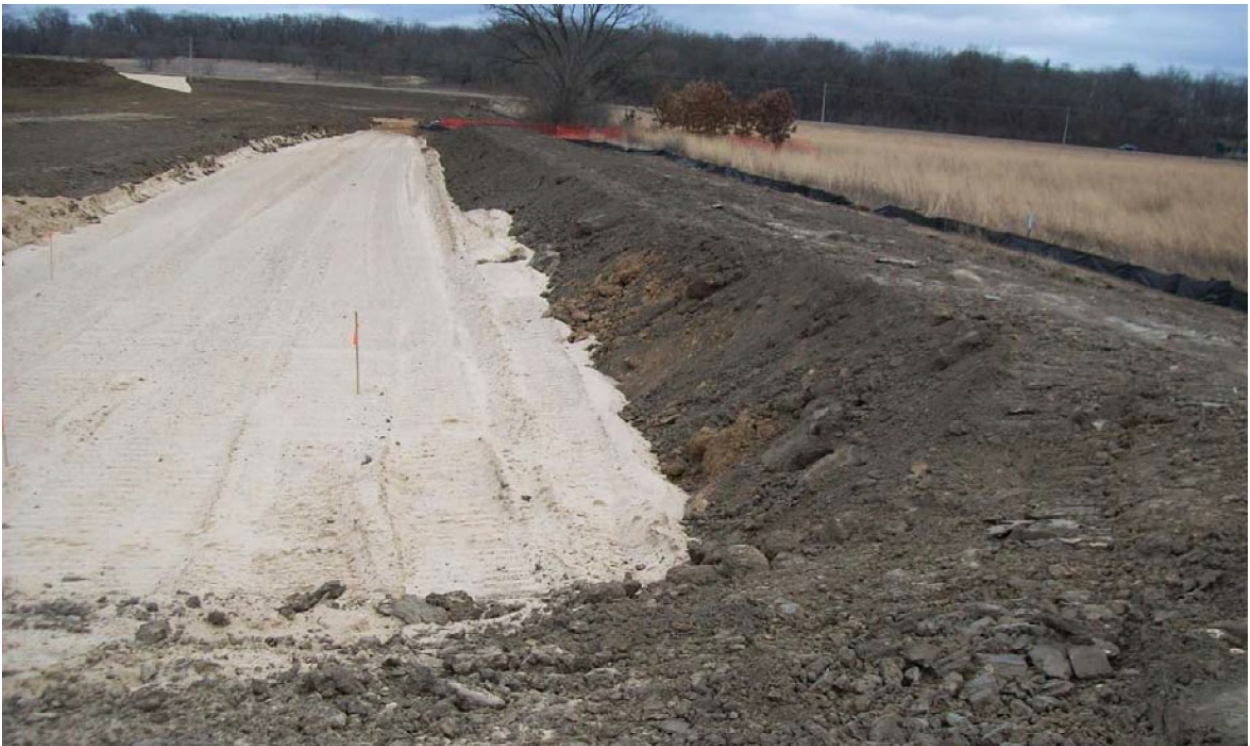
Photo 2: Infiltration basin looking east after undercutting poor soils and replacing with granular soils meeting infiltration requirements.

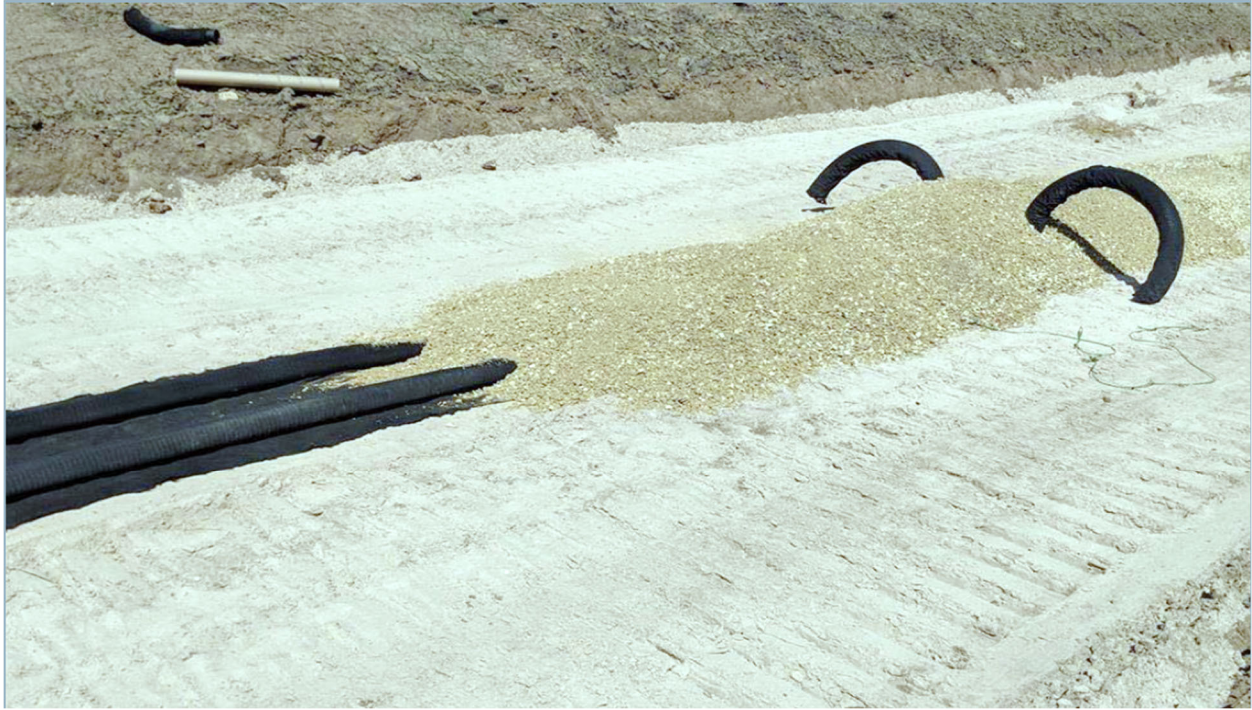
Photo 3: Infiltration basin looking north underdrain configuration

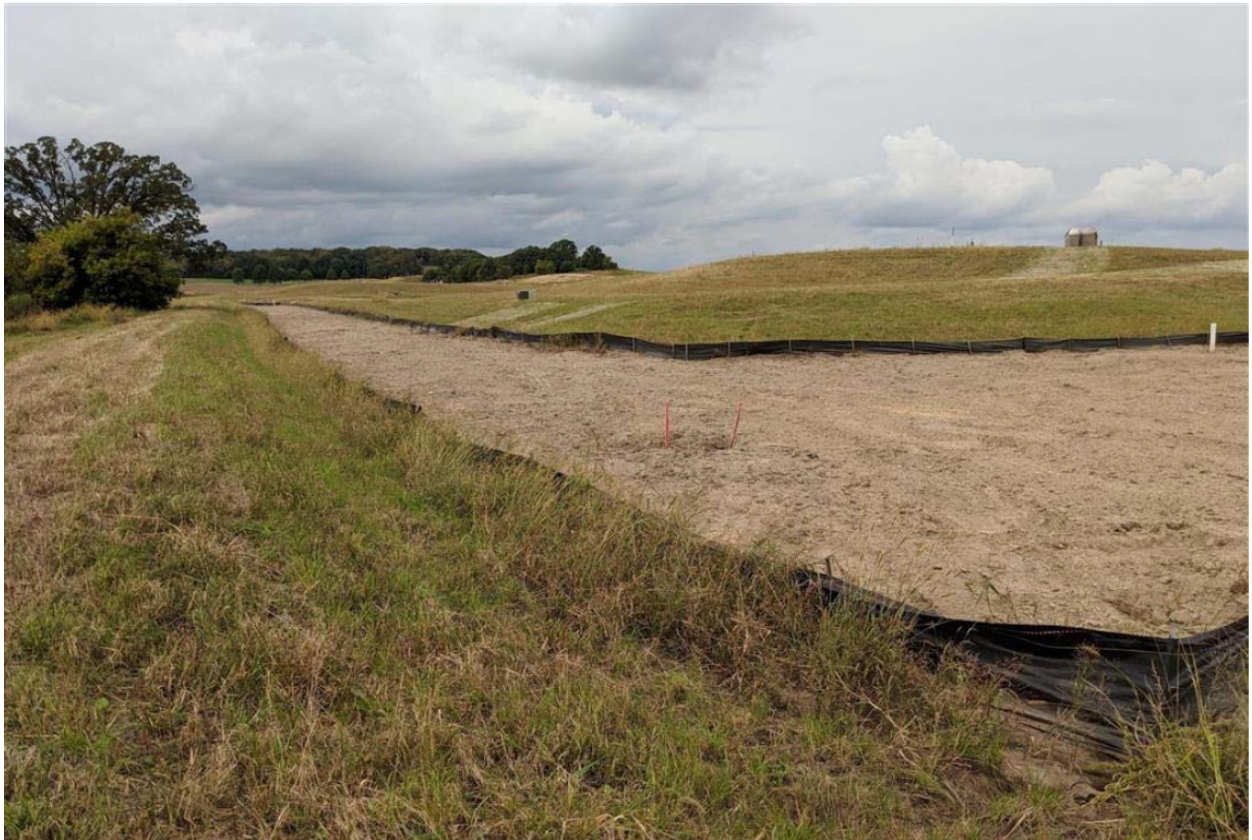
Photo 4: Bioretention basin looking northwest engineered soil prior to final grading and restoration

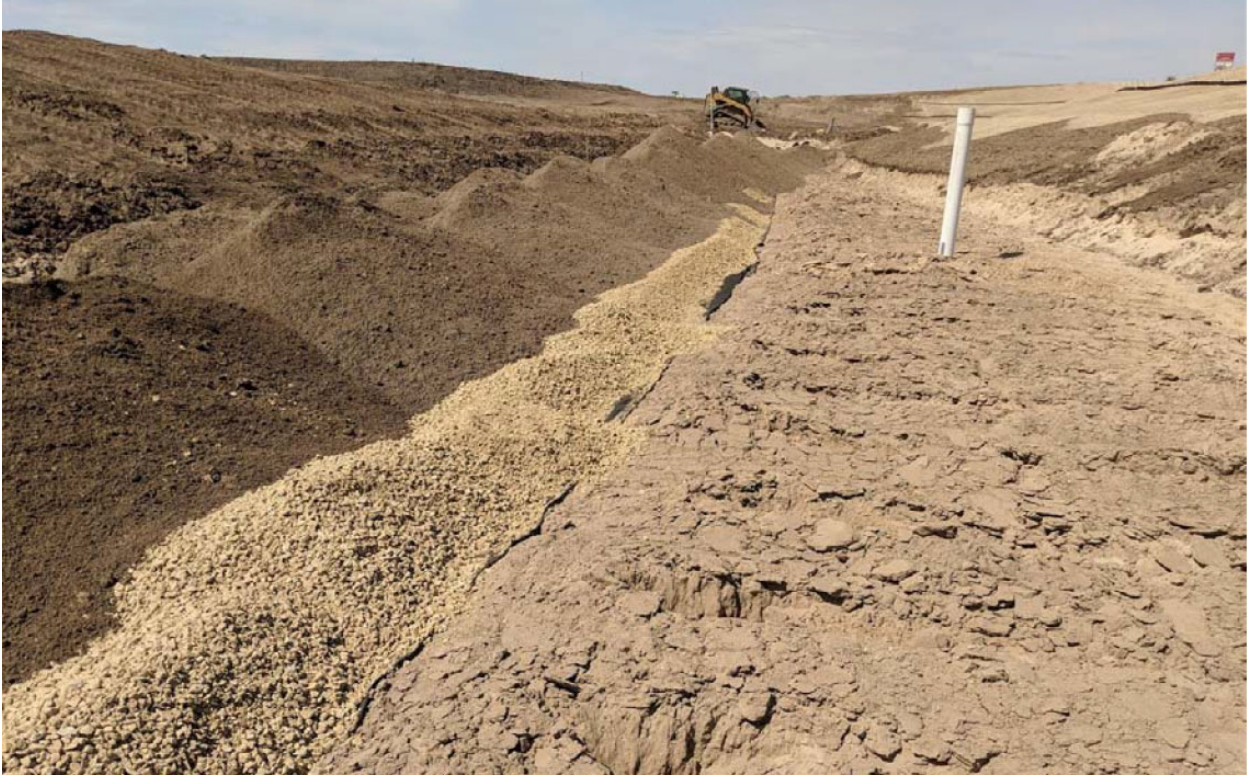
Photo 5: Infiltration basin looking north deep tilled native soil layer with under drain exposed as engineer soil placement commencing

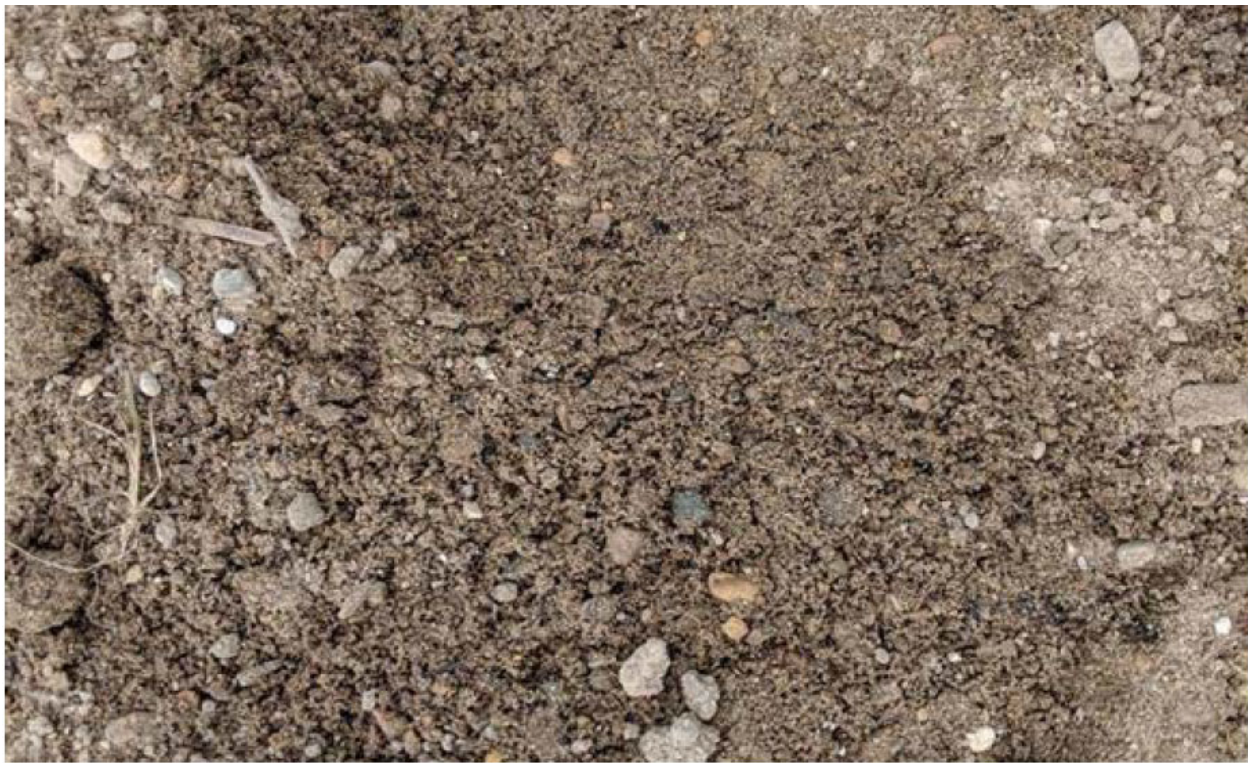
Photo 6: Engineered soil.

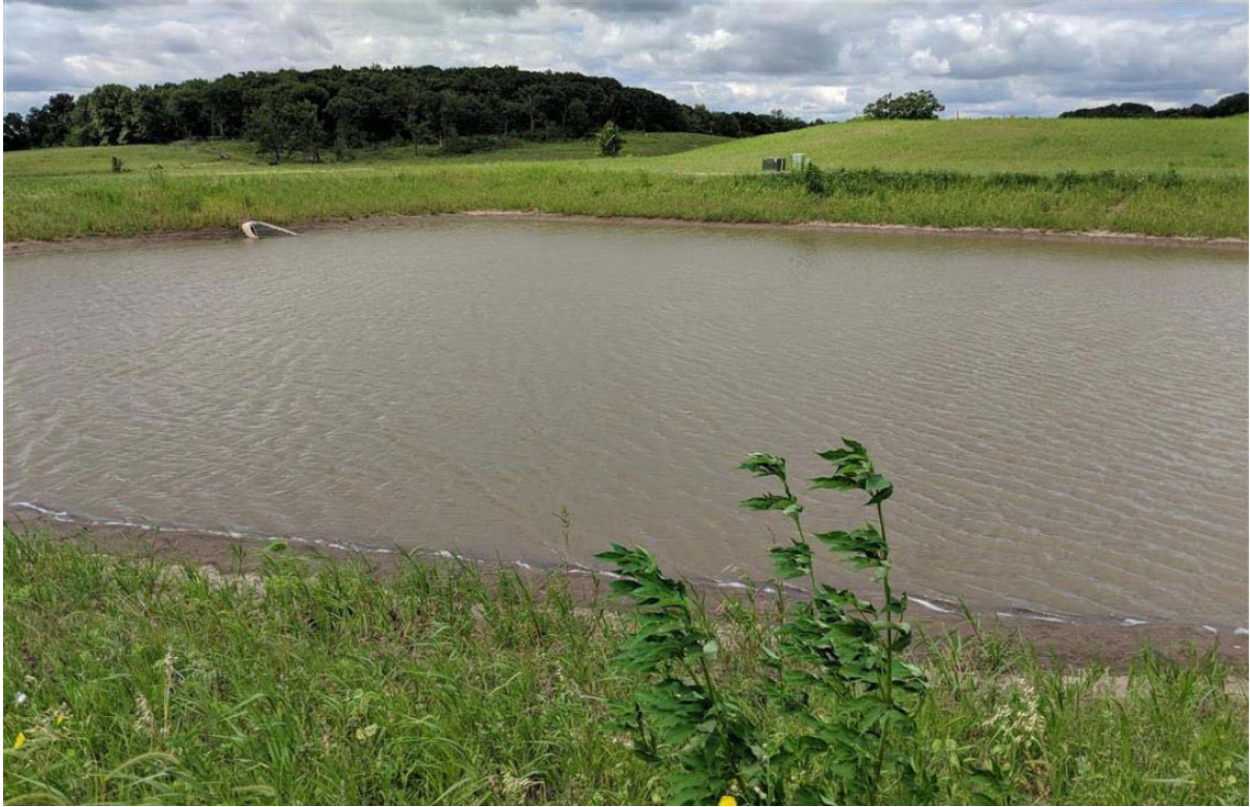
Photo 7: Wet basin looking south west fully vegetated establishment

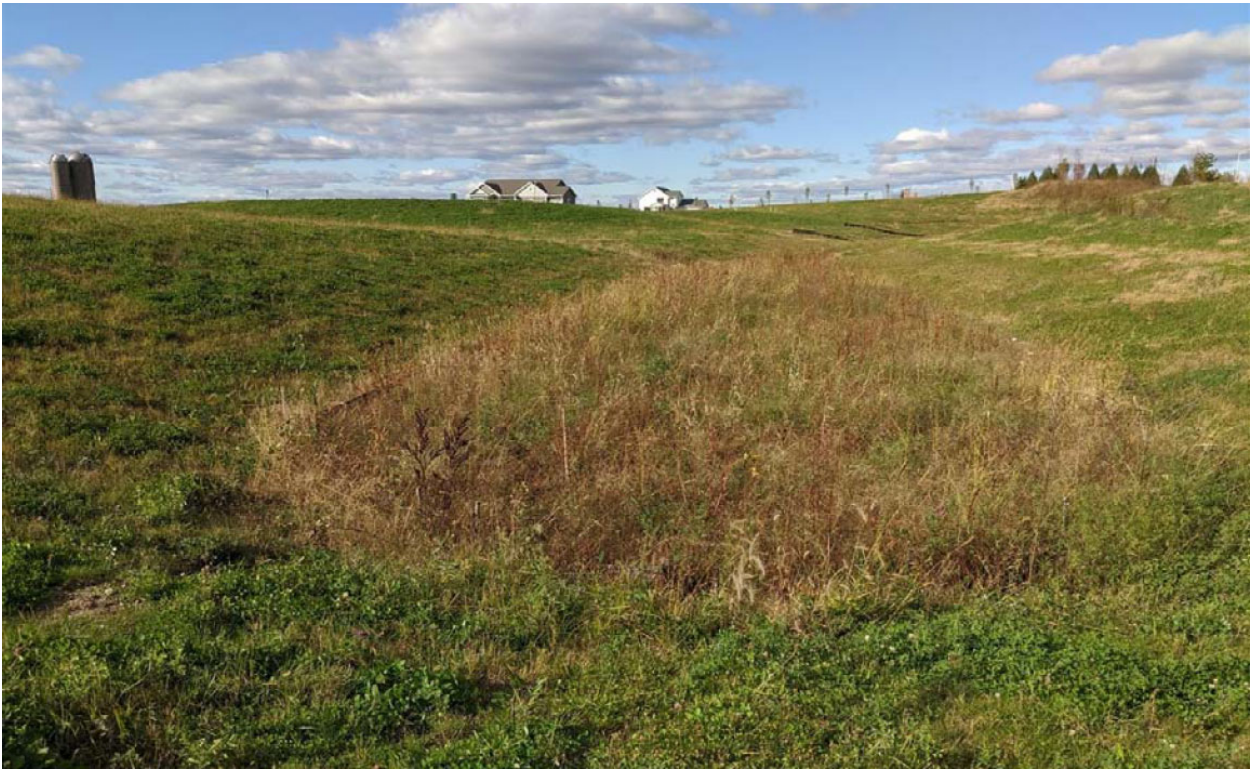
Photo 8: Infiltration basin looking north fully completed after vegetation establishment
